## AVIATION INVESTIGATION REPORT

A05O0258

### LOSS OF CONTROL – COLLISION WITH TERRAIN

RYAN AERONAUTICAL NAVION B C-FTRM

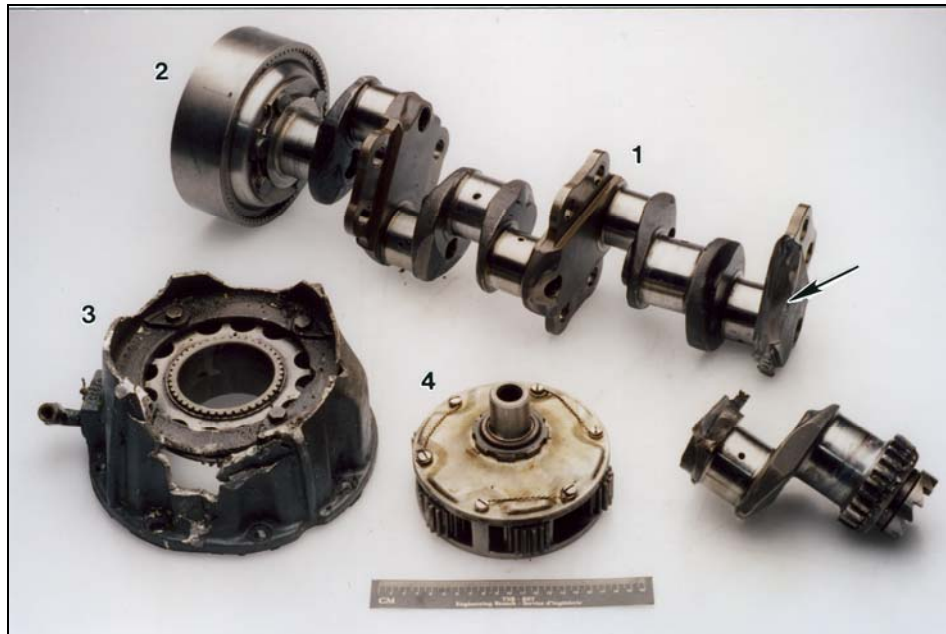
The fractured crankshaft and parts of the engine-to-propeller reduction gearbox assembly are shown in Photo 1. The location of the failure, as shown in Photo 1 by the small arrow, was at the forward fillet radius of the number six connecting rod journal (see Photo 2 – Close-up of fractured crankshaft).

**Photo 1.** Fractured crankshaft (1) and reduction gearbox assembly (2, 3, and 4)

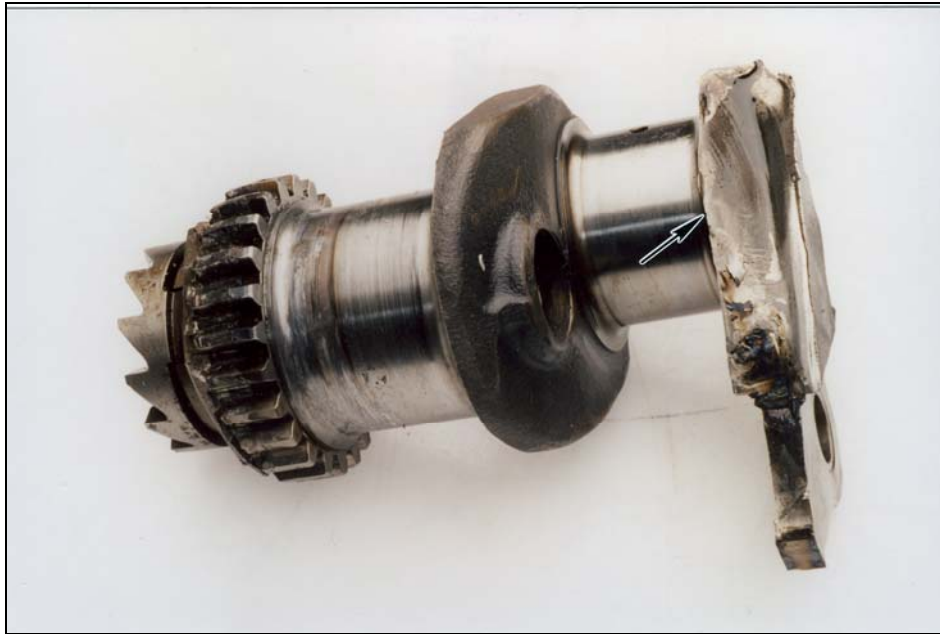
**Photo 2.** Close-up of fractured crankshaft

A crack on the crankshaft initiated on the surface of the forward fillet radius to the number six connecting rod journal. Examination of the crankshaft revealed crack progression markings that confirmed the fracture as a progressive fatigue failure. The fatigue crack progressed across 95 per cent of the cross section of the crankshaft, before its fracture. The final fracture occurred as the weakened shaft was unable to sustain the applied loads. The transition from the fatigue crack to the fracture appeared continuous, indicating that the failure occurred while the engine was being run under normal operations.

A section of the fracture surface, including the crack origin area and a portion of the fillet radius, was removed for scanning electron microscope (SEM) examination. This examination did not reveal any overload, such as a propeller strike, before or after the initiation of the fatigue crack. Close inspection of the origin area with the SEM showed regions of corrosion pitting, which may have been where the fatigue crack originated.

The material of the crankshaft was a low alloy steel containing manganese, chromium and nickel alloying additions. The general structure of the crankshaft showed hardness consistent with the required quenched and tempered heat treatment process, performed during the manufacture of the crankshaft. However, the forward fillet radius to the number six connecting rod journal and the journal surface showed an absence of case hardening at the origin of the fatigue crack. The equivalent location on the aft fillet radius and the forward radius 180° from the fatigue crack origin showed acceptable case-hardened layers. The number five connecting rod journal also showed the presence of normal case-hardened surface layers. There is no indication in the engine logbooks of any reworking of the crankshaft. It is possible that the absence of the case hardening at the fatigue crack origin dates from the time of manufacture and installation in the engine. This may have contributed to a faster crack growth rate than would normally be the case for a properly manufactured crankshaft.

The crankshaft failed as a result of a fatigue crack that developed on the forward fillet radius of the number six connecting rod journal. The crack most likely originated in an area where there was corrosion pitting. The fatigue crack developed at an undetermined time during the lifecycle of the engine and was not discovered on any of the three overhauls that were recorded in the aircraft logbooks. The crack appeared to have spread under normal operating conditions until the crankshaft could not support the required operating loads. The absence of a case-hardened layer on the fillet radius in the region of the fatigue crack initiation also contributed to the failure. The deficiency in the material heat treatment condition is believed to have been the result of a manufacturing error. Fatigue failure of the engine crankshaft resulted in a complete loss of power.

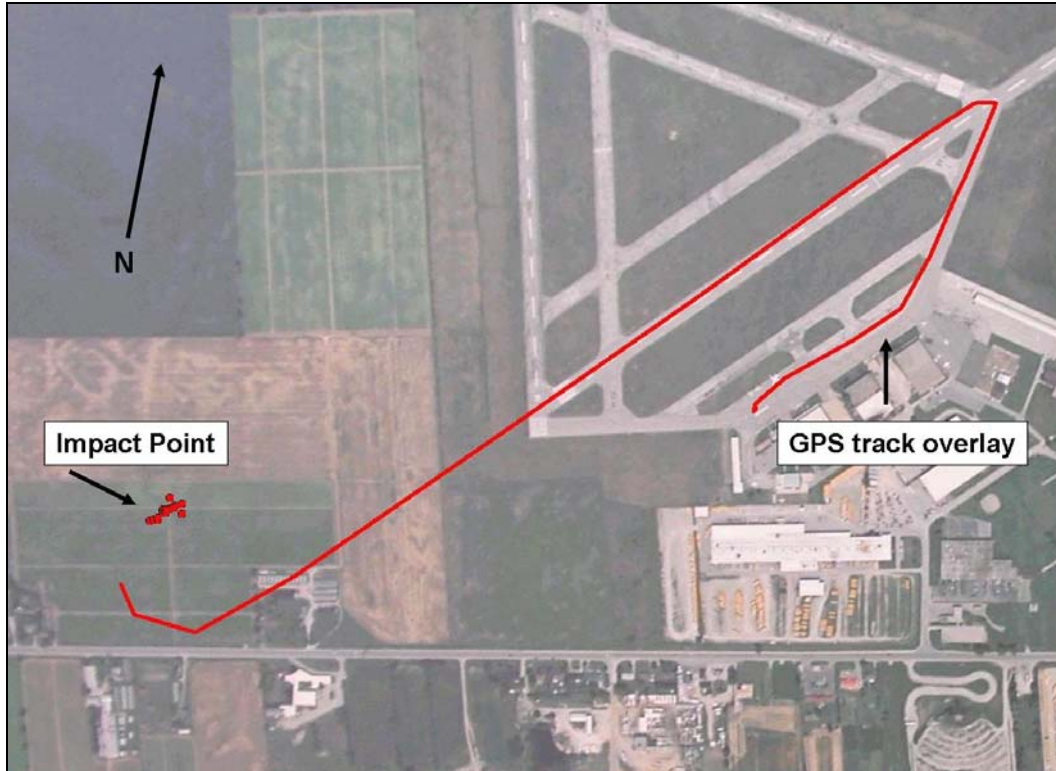
The aircraft was equipped with a Garmin 295 global positioning system (GPS). Although extensively damaged during the accident, the GPS memory was successfully downloaded at the TSB Engineering Laboratory. Information regarding the occurrence take-off was retrieved from the GPS (see Appendix B – GPS Overlay of Brantford Airport). The data indicated that the aircraft climbed at a rate of 850 feet per minute (fpm) until reaching an altitude of 450 feet above ground level (agl). The groundspeed decreased from 72 mph to 48 mph and the track of the aircraft increased from 222° T to 273° T before any loss of altitude. The rate of descent was initially 1300 fpm and increased to 3000 fpm before impact.

**Photo 3.** Overhead view of airport and crash site with GPS track

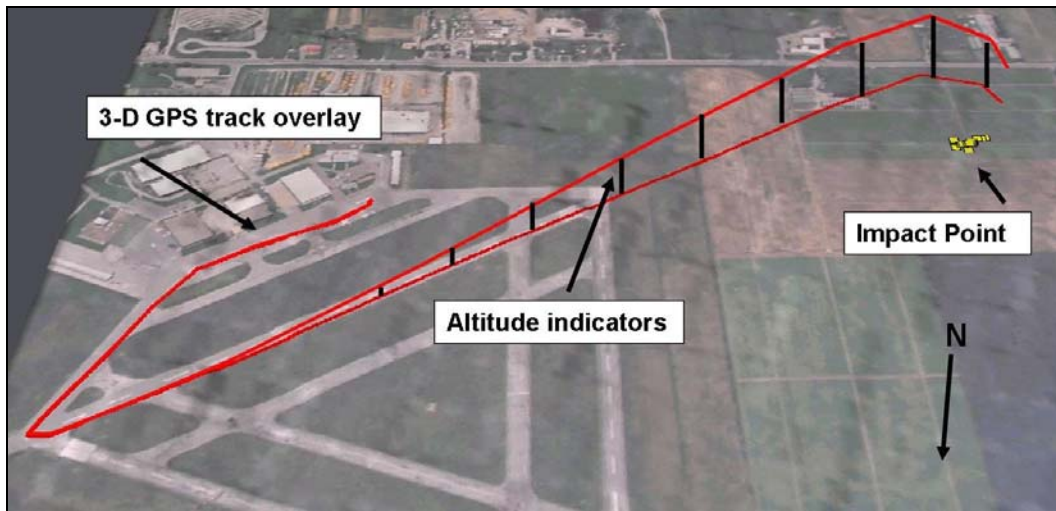
**Photo 4.** Overhead view of airport and crash site with 3-D GPS track overlay
